Traditional Period (1880 - 1900)

Early Structures (1880-1885)

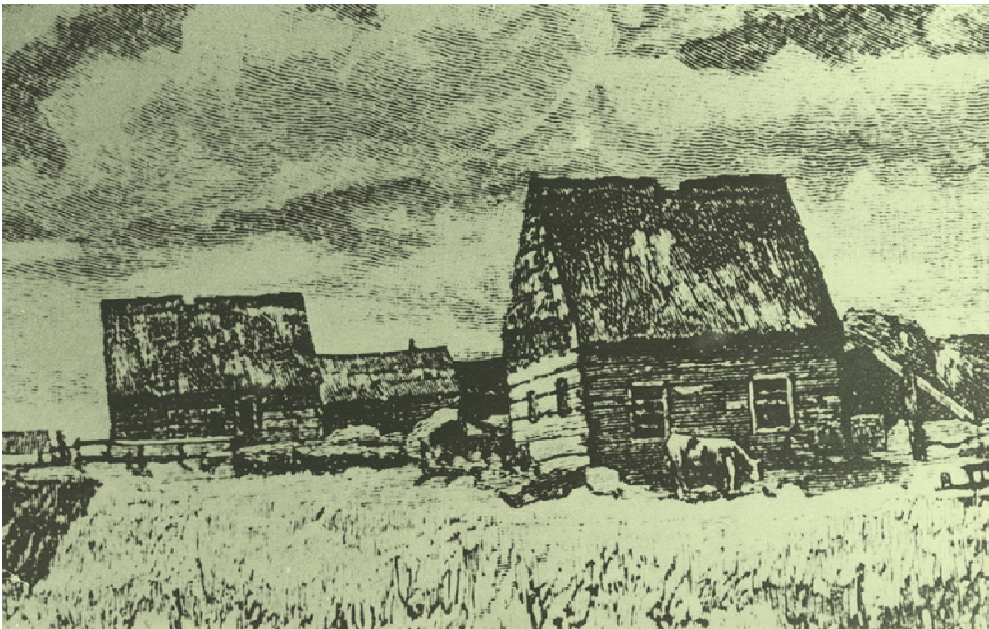
Figure 10

Early Mennonite homes in the West Reserve, as depicted by a newspaper artist, ca. 1878. (Provincial Archives Manitoba)

The initial shelters constructed by the Mennonites were usually replaced within a few years by more secure structures. Although these structures usually followed the traditional house/barn design of the Russian colonies, there is still neither the time nor the materials available for the construction of large permanent buildings with carefully worked details. Many of these first house/barn units and especially the barn sections were small and hastily constructed (Figure 10).

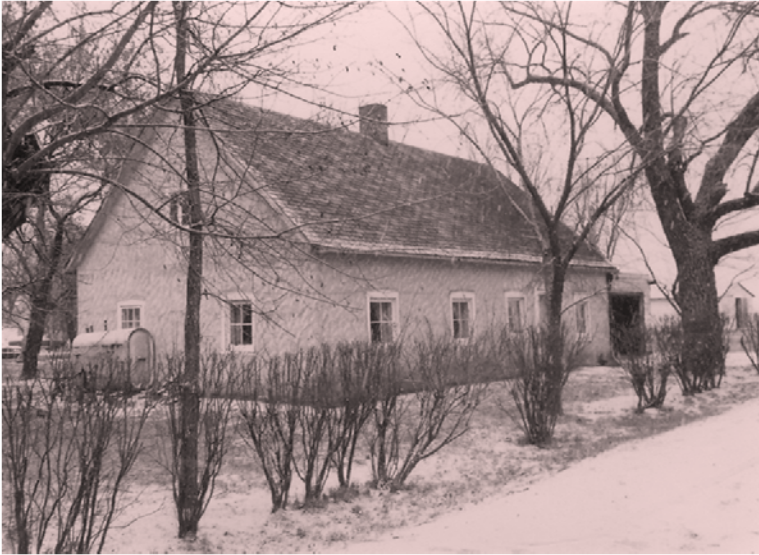
Figure 12

Peter Wiebe residence,
Hochfeld, ca. 1876.

Fortunately, several early log structures still survive in the MSTW district, although they are rapidly deteriorating. As one would suspect from descriptions of pioneer Mennonite life, these log buildings seem to have been relatively crude and hastily built. One example, built around 1876 in the village of Hochfeld and still occupied, has logs that were sawn smooth on the inside but left round on the exterior side (Figure 12). In this example saddle notches were used at the corners. A rare example of post and fill construction still exists in the village of Osterwick (Figure 13).

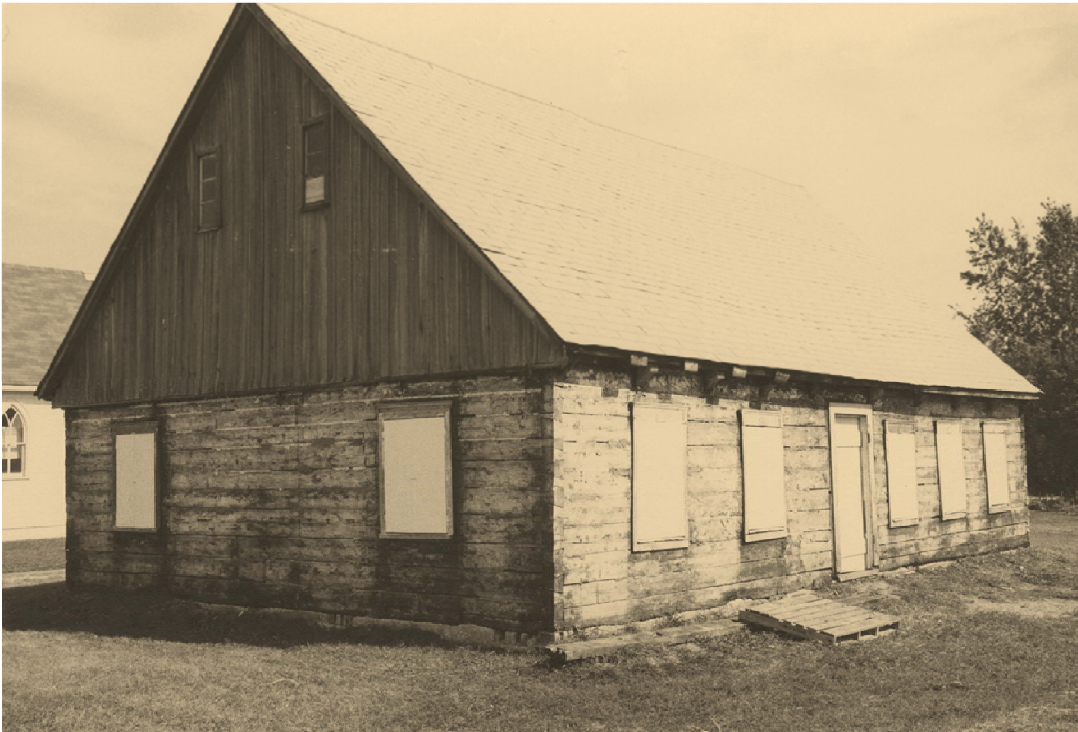
Figure 15

The majority of early log houses featured the dovetail method of log construction. This example, now a museum piece, is one of the few remaining good examples in the MSTW district.

Another early house, constructed around 1878 and now located at the Pembina Valley Thresher men's Museum near Winkler, exhibits the more commonly used dovetail method of log construction (Figure 15).

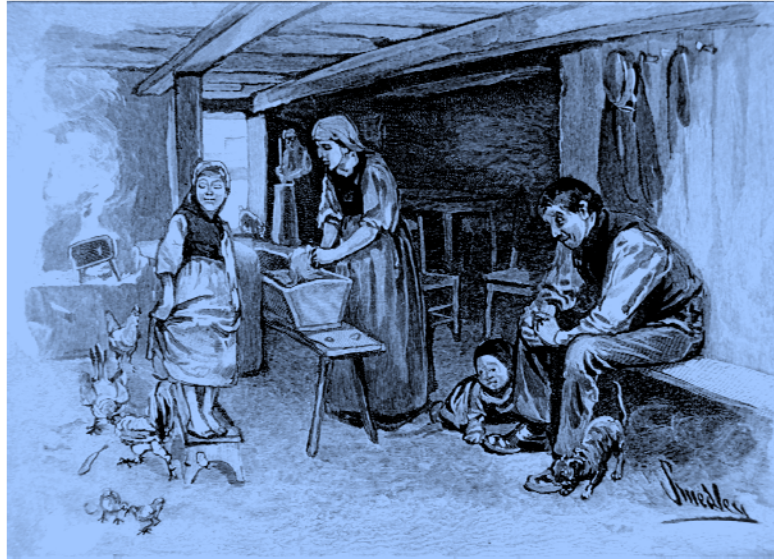
Figure 17
Interior scene of an early Mennonite home, as depicted by a newspaper artist. (Provincial Archives Manitoba.)

Although basic construction methods varied, most of the early log homes were very similar in appearance. Walls were plastered inside and out with a mixture of clay and straw to which a layer of whitewash was applied, Hardening the surface and giving it a more finished appearance. The thick plaster also served to insulate the building, keeping it warm during the winter and cool during the summer months. Roofs were constructed of grass thatch obtained from the edges of sloughs or creek banks. Initially, holes were simply left in the roof for smoke from the cook stove to escape, but before long tin stovepipes were introduced. Often the floors of early homes were of earth, hardened with sour milk and wood shavings. Cut lumber was used sparingly, usually for the ceiling, gable ends, doors, and occasionally for a floor. Since hinges, latches and furniture were normally homemade from logs, the only additional cost, besides lumber, was the cost of a few nails (Figure 17).

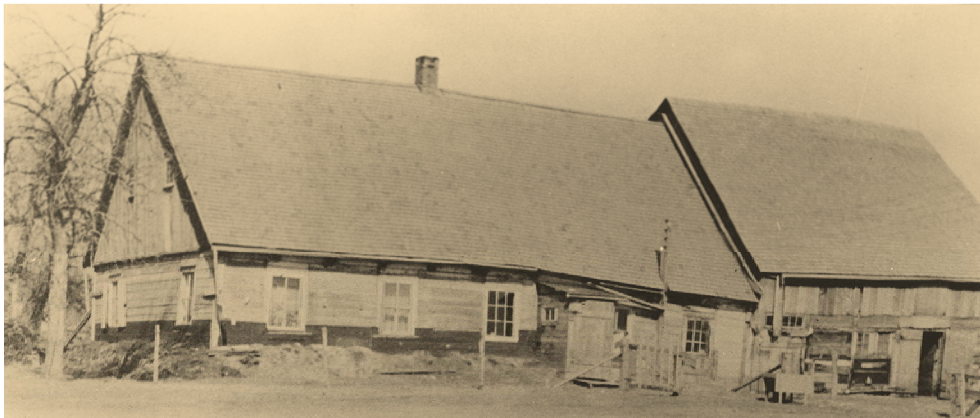
Figure 18
An early house/barn unit, ca. 1878. Note the small barn section. (Winkler, 1982: 162.)

Barns were generally added a few years after the house was completed. The few head of stock kept during the early years were housed in the initial sod or thatch shelters until a more secure structure could be built. None of these small early barns still survive in the MSTW District; however, photographs suggest that many of these consisted simply of a small stable area with hay storage in the loft above (Figure 18).
