Farm Outbuildings

Barns

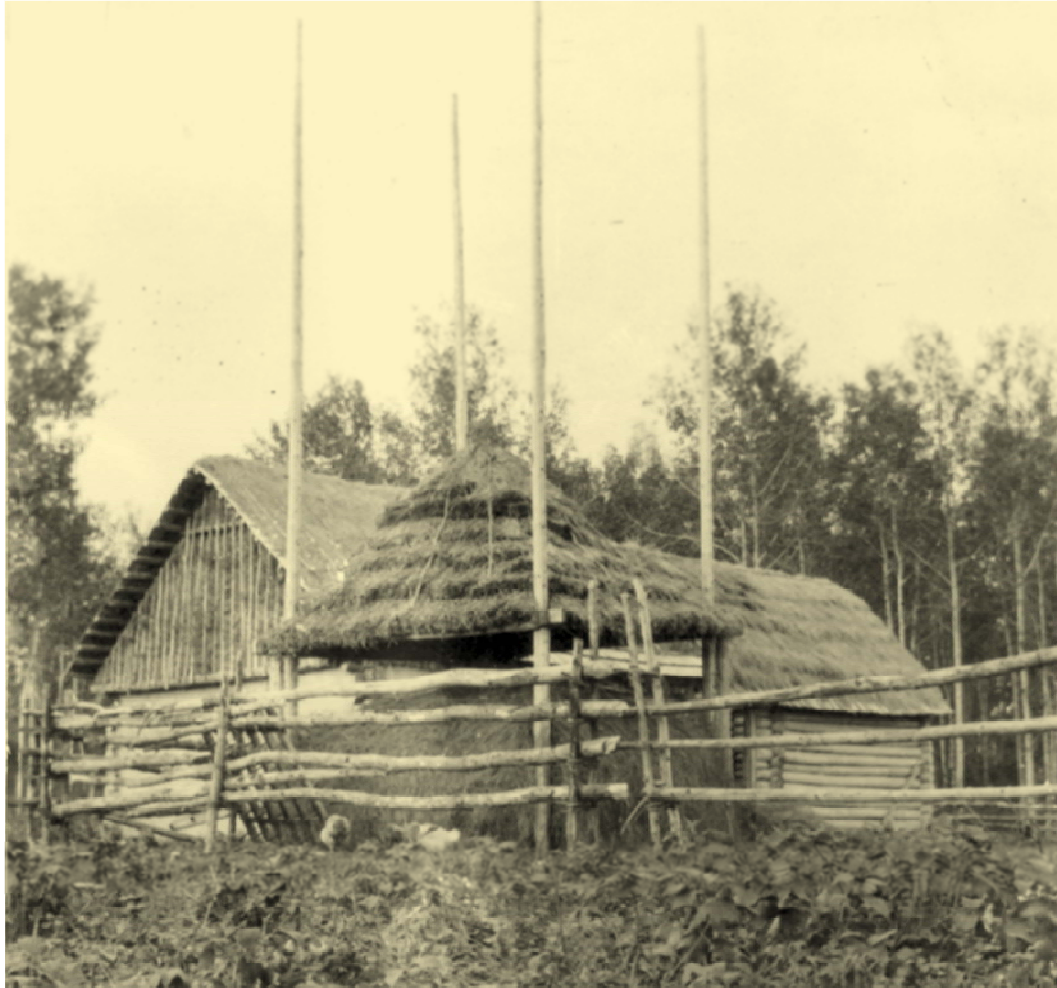
Figure 23
Early log barn in the Foley area. Feed hay was stored under the thatch-roofed structure in the foreground. (Provincial Archives Manitoba)

As with most other immigrant groups, the initial barns and other farmyard buildings constructed by the Ukrainians were considered only temporary facilities and were rather hastily built. They were generally built of green unpeeled logs using a simple saddle or crude dovetail notch at the corners. The roofs were roughly thatched or simply stacked with grass (Figure 23).

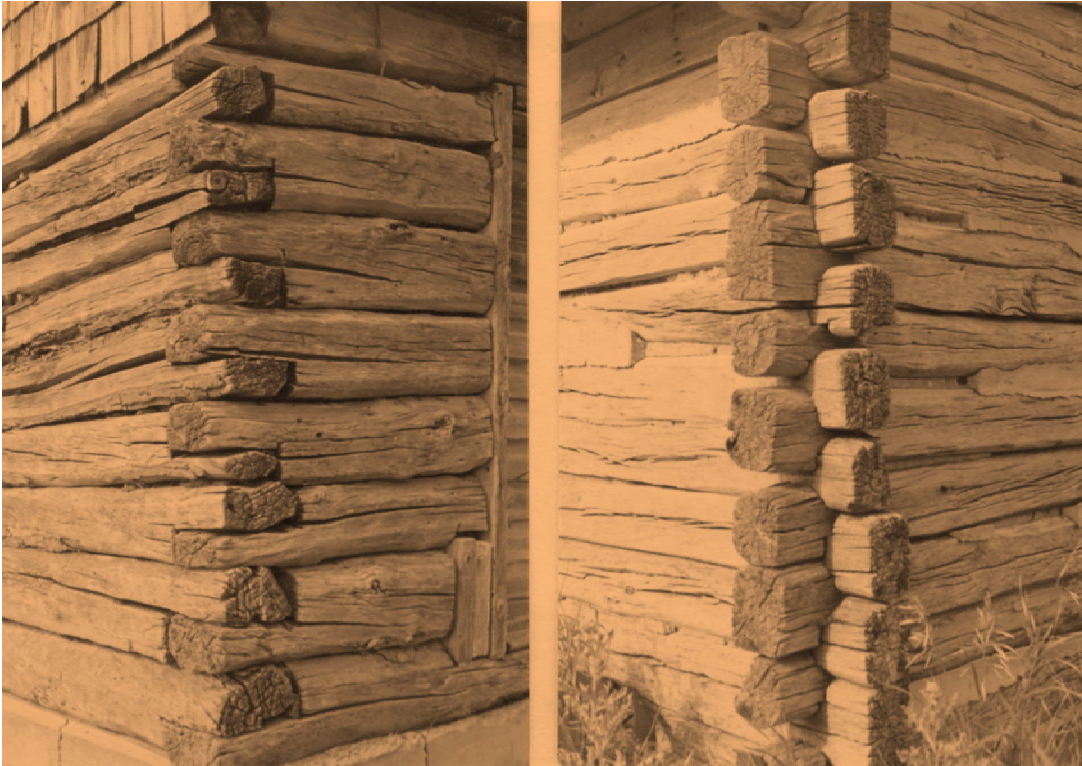
Figure 26

Lap notches, on the left and lock notches, on the right, were occasionally used in the construction of log buildings in the Eastern Interlake.

While the dovetail corner notch was most common in the Eastern Interlake during this period, several other notches were also used. Buildings were found displaying the lock notch, the lap notch, and the post and fill or Red River frame method (Figure 26).

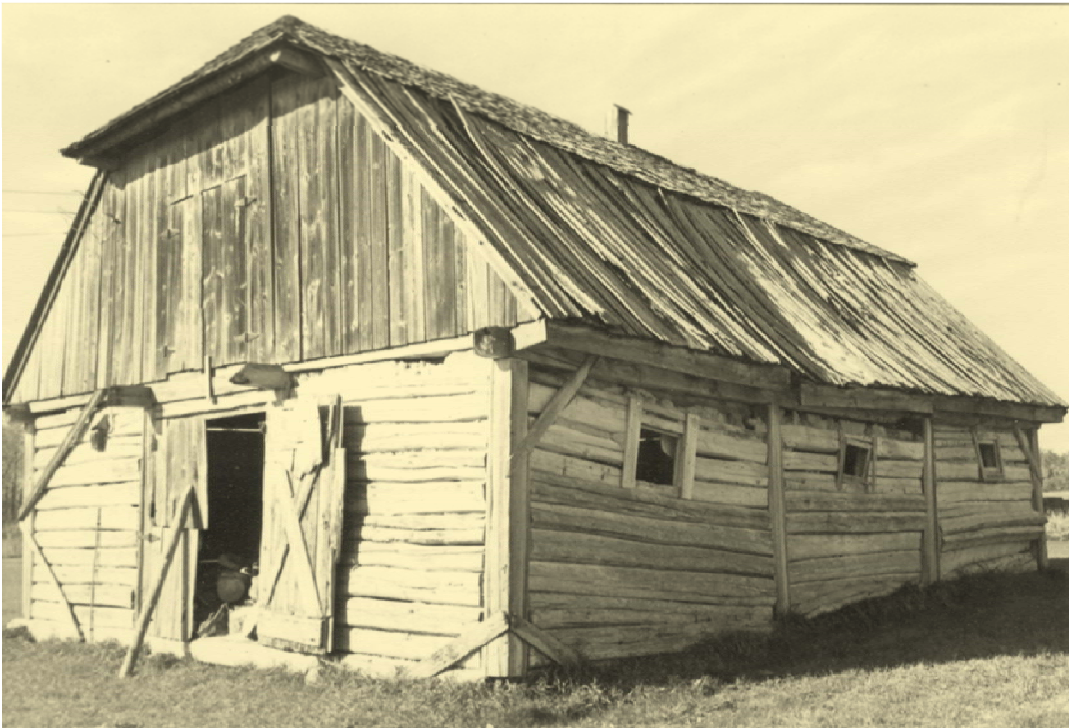
Figure 27
Rostkowski barn, SW 4-22-1E, ca.
1925.

In addition to the post and fill construction, it has an unusual hipped gambrel roof with split shingles on the crown and vertical board and batten roofing on the lower portions. The building was carefully constructed and displays several obviously well planned design elements (Figure 28).

Only two examples of the latter were found in the areas of Ukrainian settlement. The Rostkowski barn in the Framnes area is an interesting example (Figure 27).

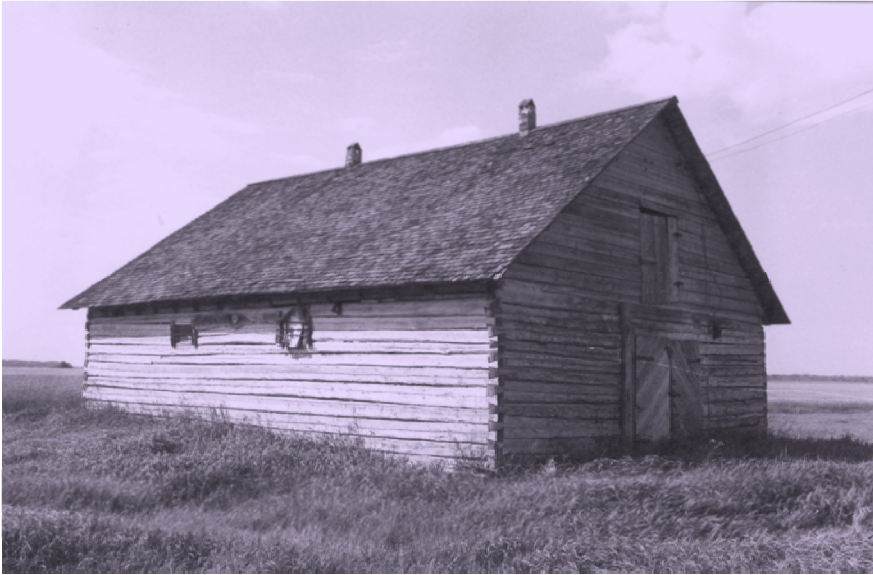
Figure 29
Kwizina barn, SE 9-24-2E, ca. 1925.

Prior to the 1920s thatched roofs were still common and were much more carefully constructed than those on the initial buildings. The hipped roof, which was better suited for the thatching process than the gable roof, was quite common during this time and even appeared on Galician structures. Milled lumber was used sparingly during the early 1920s and was usually reserved for the doors and gable ends. The thatched roofed barns rarely had lofts: hay was stored in stacks outside the structure. By the late 1910s new styles and construction methods were being adopted and traditional elements began to disappear. Thatched roofs were replaced with wooden or tin covered ones. With a change in roofing material, the roof shape changed as well. A lower pitched gable shape became common (Figure 29), and the gambrel roof was appearing on many of the new barns being constructed.

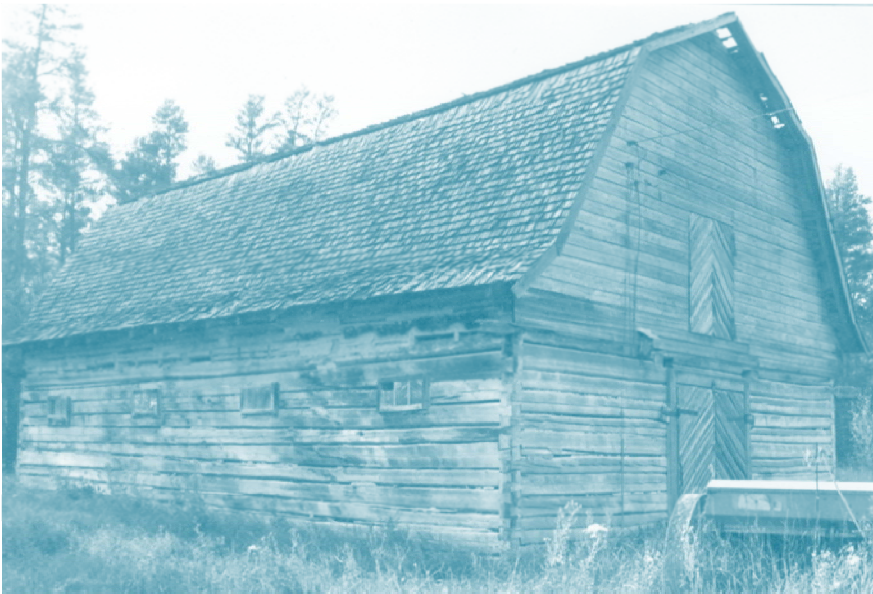
Figure 30
Chomokovski barn, NE 14-24-2E, 1934.

This was an improvement over the gable shape as it had a greater storage capacity (Figure 30). The use of concrete foundations and wood siding on the exterior of walls to eliminate the constant maintenance that mud plaster walls required, also appeared during this period.

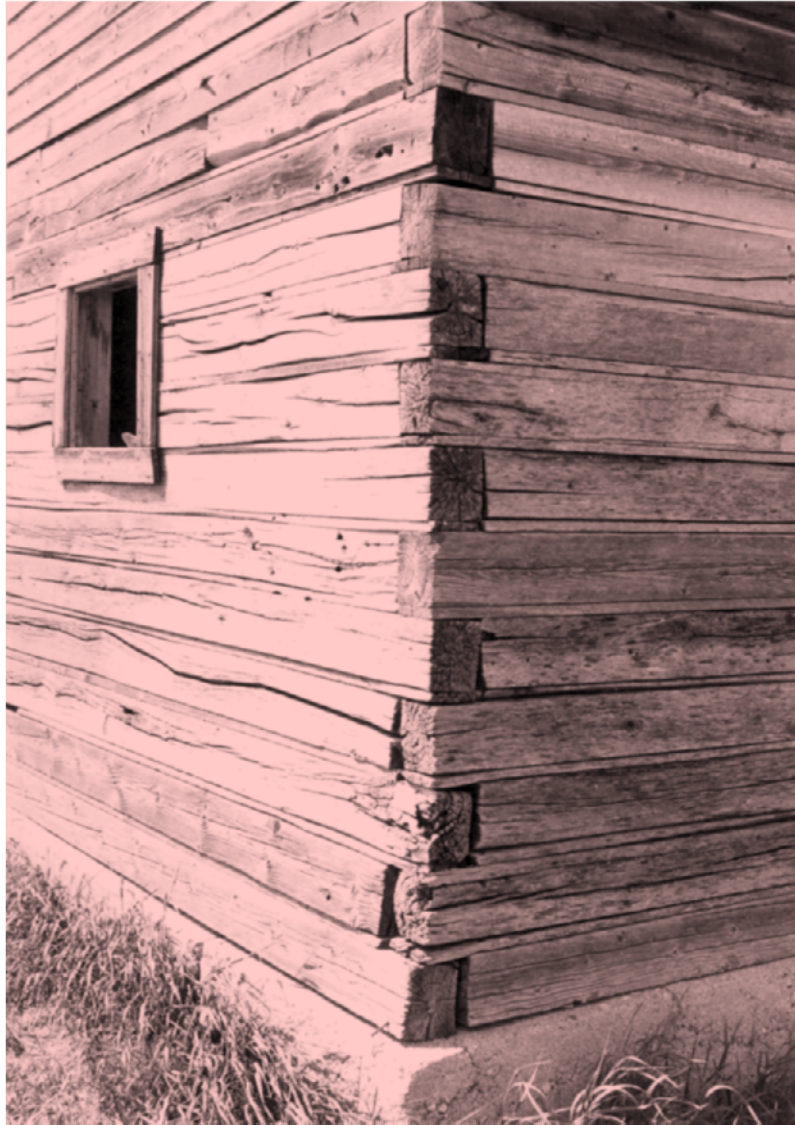
Figure 31
Gislason barn, SW 33-22-3E, ca. 1940.
This corner detail shows the simple
spiked lap joint.

Despite the depression of the 1930s, frame lumber barns began appearing, although log construction was still occasionally used as late as the 1940s. In many cases these later log barns were constructed with timbers which were sawn square and joined at the corners with a simpler spiked lap (Figure 31).

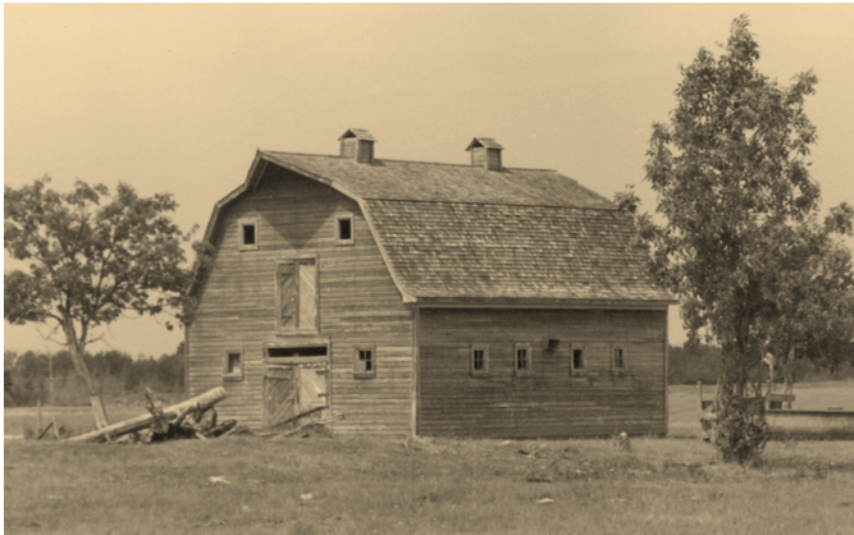
Figure 32
Farm barn, SE 33-21-3E.

During the post war period, few of the farm buildings constructed by Ukrainians in the Eastern Interlake displayed any traditional elements. They were all frame lumber structures of contemporary design similar to those being built in any other area of the province (Figure 32).
